# Manhole Inspection Summary

Manhole # S19AA2012MH

**Location** Address: **1701 MT. WASHINGTON CT**

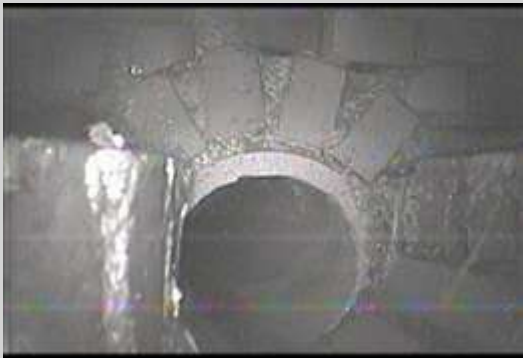
### 8 in. Circular Gravity Sewer Pipe Out @ 12 O'Clock

Pipe Material: **Clay** ☐ Pipe Lined

Infiltration: **None** Pipe Seal Cond: **Unknown**
